**US Army Corps
of Engineers**

Technical Report CHL-99-3
March 1999

Monitoring Completed Navigation Projects Program

Inspections of Previously Monitored Coastal Structures

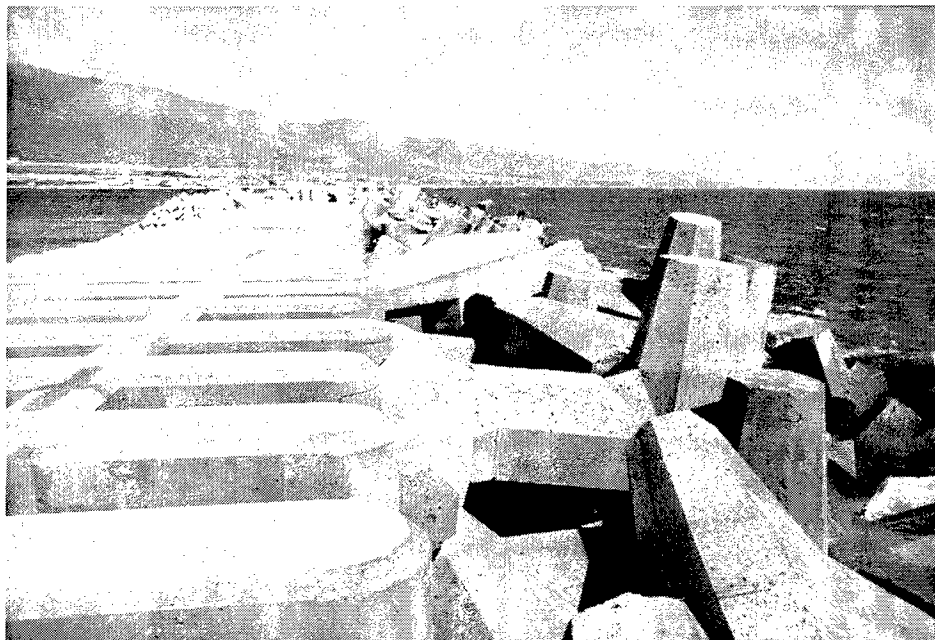
The Kahului Harbor breakwaters were inspected on 21 July 1998. The inspection, as close as could be observed visually, indicated that most of the armor unit positions were similar to those obtained during the 1993 survey. Views of the structures are shown in Figures 6 and 7. On the east breakwater it appeared that two 31,750-kg (35-ton) tribars had flipped and slid downslope slightly on the sea side of the structure at approximately sta 10+50. Additional breakage of some of the 5,445-kg (6-ton) dolosse

Figure 6. Kahului east breakwater

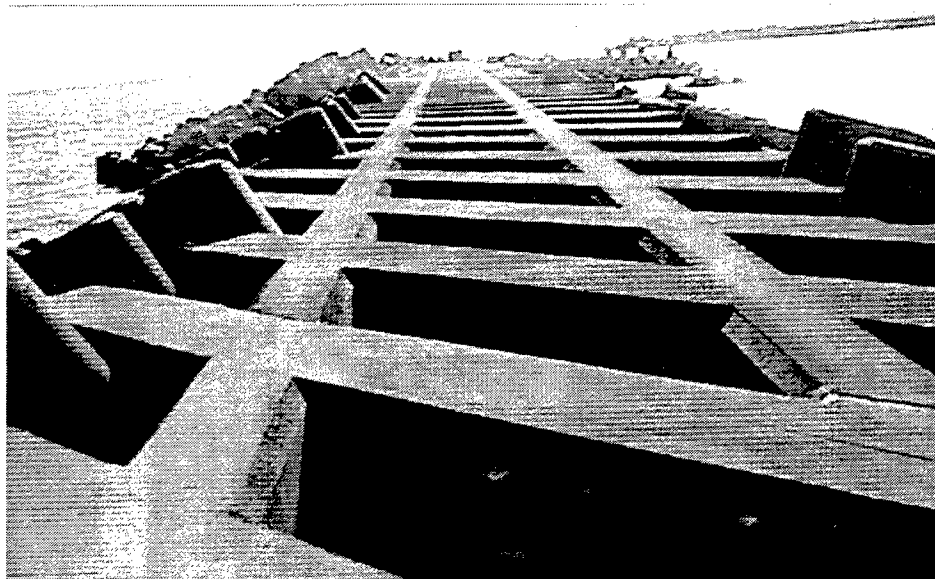
Figure 7. Kahului west breakwater

(sta 6+20 thru 7+10) on the sea side of the structure was noted since the 1993 survey. Eleven broken units were observed in this area as opposed to nine documented broken units during the 1993 survey. During the west breakwater inspection, a concentration of broken 27,215-kg (30-ton) dolosse was noted on the sea side of the head. Twelve broken/cracked units were observed versus eleven documented during the 1993 survey. Also, some of the 5,900-kg (6.5-ton) tribars on the harbor side of the breakwater close to its head appeared to have lifted and tilted downslope

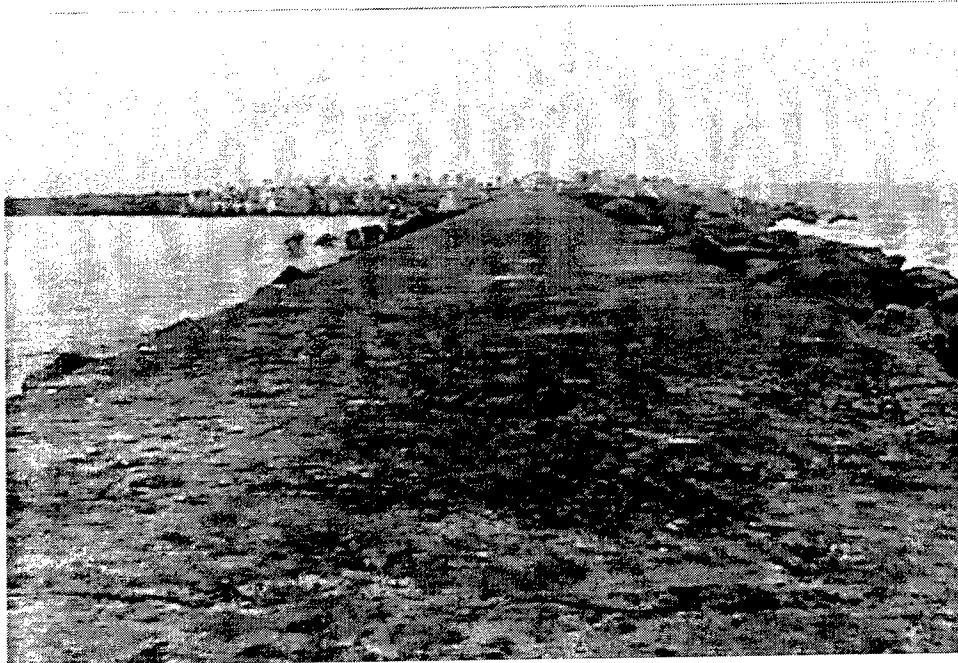
The Crescent City Harbor breakwater (Figure 27) was inspected on 15 September 1998. The inspection indicated that most of the armor unit positions were similar to those shown in the 1993 photography as close as could be observed visually. It appeared that only a couple of the 38,100-kg (42-ton) units had changed positions slightly along the water-line at the outer portion of the main stem. Figure 28 shows some of these units at the head of the main stem of the breakwater. Numerous broken armor units were observed, but were validated as being broken in the 1993 survey. Overall the structure is in good condition.

Figure 27. Crescent City Harbor breakwater

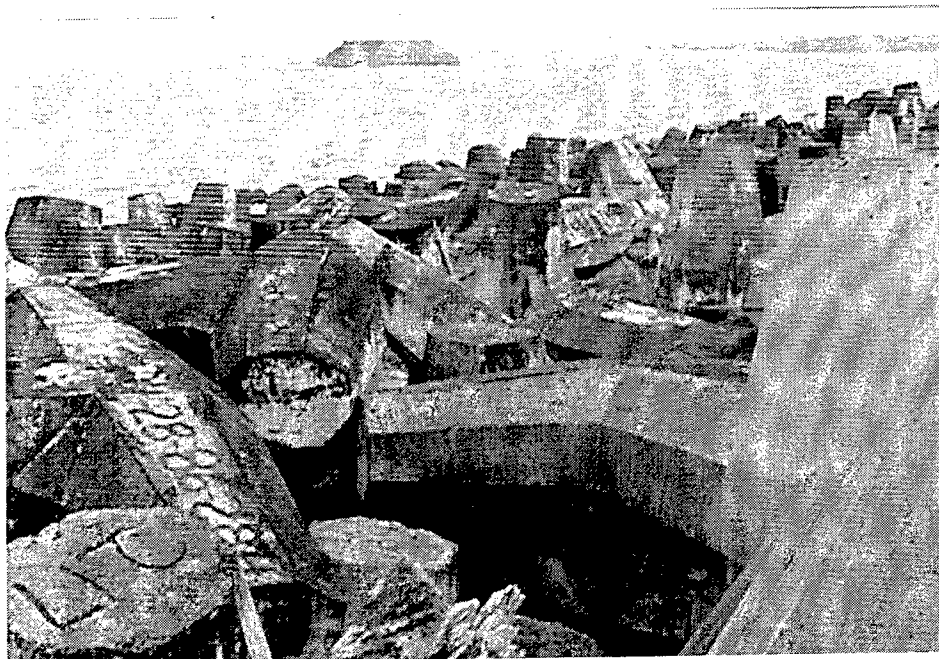
Figure 28. View of 38,100-kg (42-ton) dolosse on the sea-side slope of the main stem of the Crescent City breakwater

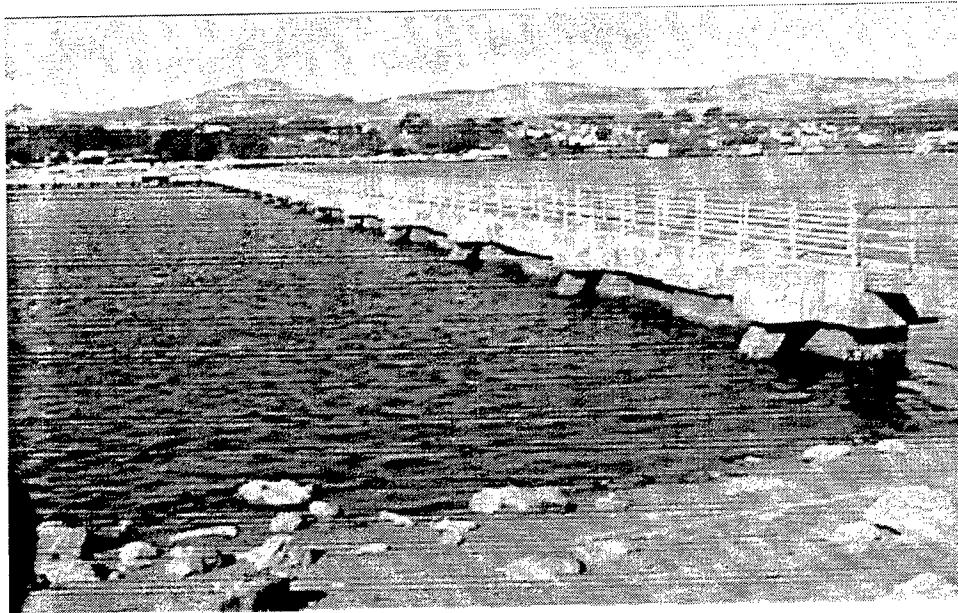
The Spud Point Marina breakwater (Figure 30) was inspected on 16 September 1998. The assessment revealed no evidence of misalignment, movement, spalling, or subsidence of the structure. The hairline cracks across the top of the breakwater cap noted in the earlier surveys did not appear to have widened (Figure 31). Additional hairline cracks were observed, particularly on the vertical sides of the cap. Some of these cracks

Figure 30. View of marina side of shoreward leg of Spud Point breakwater

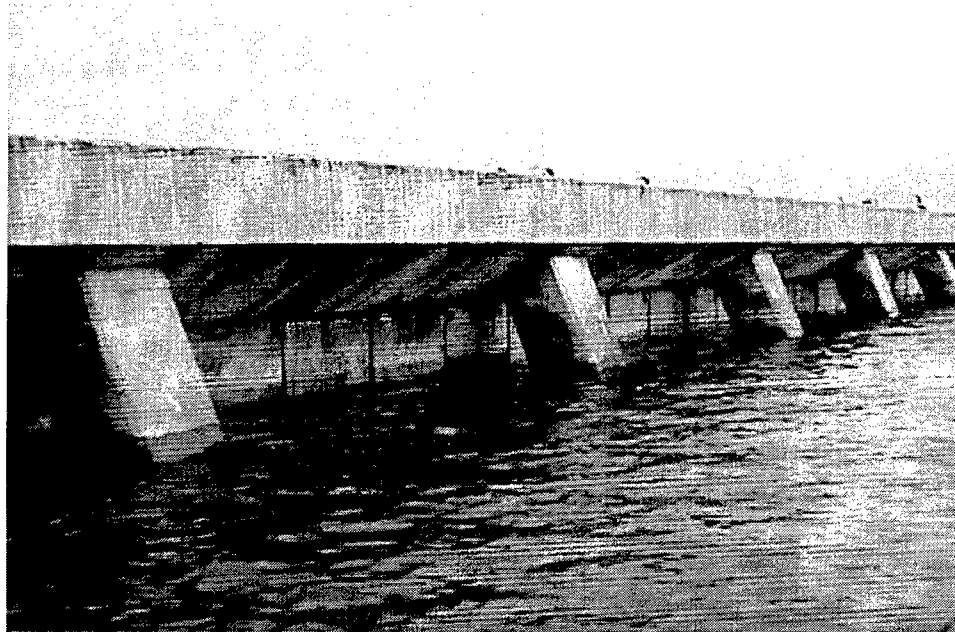
The Fisherman's Wharf breakwaters were inspected on 17 September 1998. Visual assessment of the structures was conducted by running a boat along the sides of the breakwaters and walking the main breakwater cap. A portion of the main detached breakwater is shown in Figure 34. The inspection revealed no deterioration or apparent settlement of the breakwaters. Numerous areas along the concrete piles between the main breakwater cap and the waterline were spalled (Figure 35). These areas are not threatening the structural integrity or function of the structure. The overall condition of the breakwaters was very good to excellent.

Figure 34. Portion of detached breakwater at Fisherman's Wharf Harbor

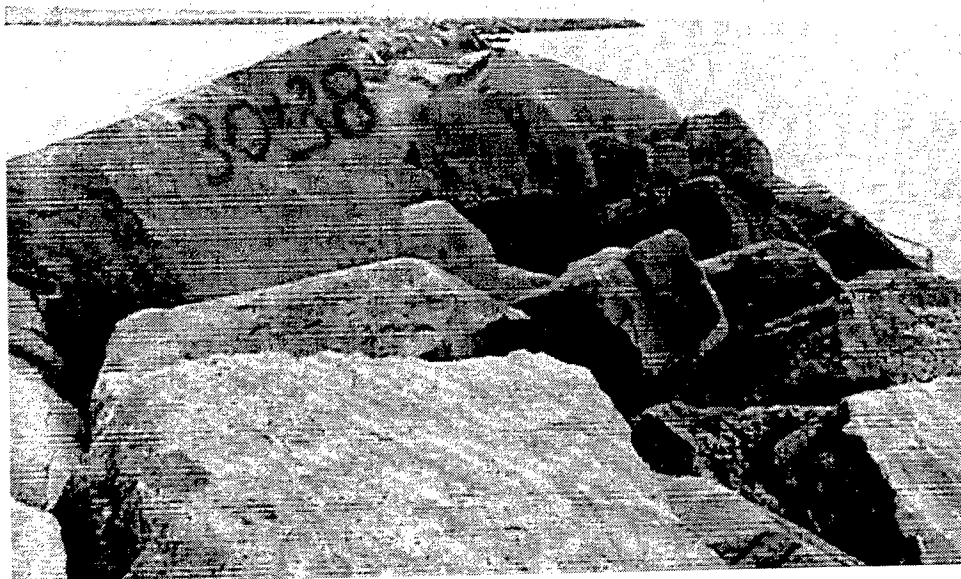
The Burns Harbor north breakwater (Figures 37 and 38) was inspected on 17 June 1998. The elevation of the breakwater was compared to topography data obtained previously during the photogrammetric analysis. Sections of the structure in which it appeared that low areas existed since the last inspection are shown in the following tabulation.

Figure 38. Burns Harbor breakwater looking west

Station	Harbor Side	Crest	Lake Side
7+50			X
9+20		X	
9+60		X	
11+65	X		
12+25		X	
14+40	X		
15+20		X	
18+30		X	
22+00	X		
24+00			X
24+30		X	
24+60			X
26+50			X
29+35		X	
30+45		X	
31+40		X	
35+70		X	
41+15	X

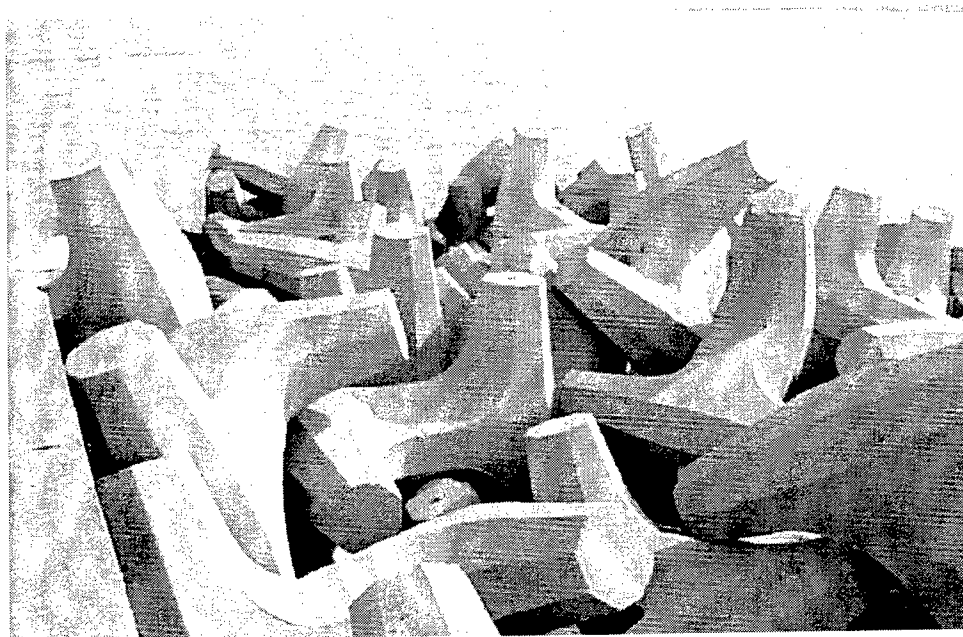
The Cleveland Harbor east breakwater (Figures 42 and 43) was inspected on 7 October 1997. The inspection revealed that the structure has changed little since the 1993 survey. Comparison of armor unit positions

Figure 42. View of 3,628-kg (4-ton) dolosse at head of Cleveland Harbor east breakwater

with detailed, rectified aerial photography, in general, revealed that most of the armor units were in the same position as in 1993. Even fragments of broken dolosse were in the same positions based on the aerial photographs. Apparent armor unit movement was observed at only one location along the structure. At sta 262+55 one dolos had moved downslope slightly and an adjacent dolos had flipped upslope. It was also noted that some new 3,628-kg (4-ton) dolosse had been placed between sta 253+50 and 254+00 since 1993. The structure is in fair to good condition and appears to be functioning well.

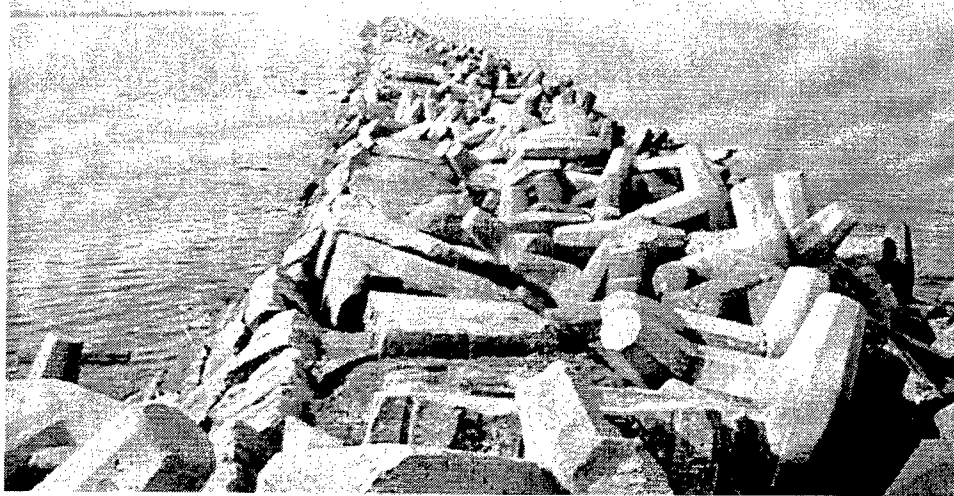
Figure 43. View of 1,814-kg (2-ton) dolosse along trunk of Cleveland Harbor east breakwater

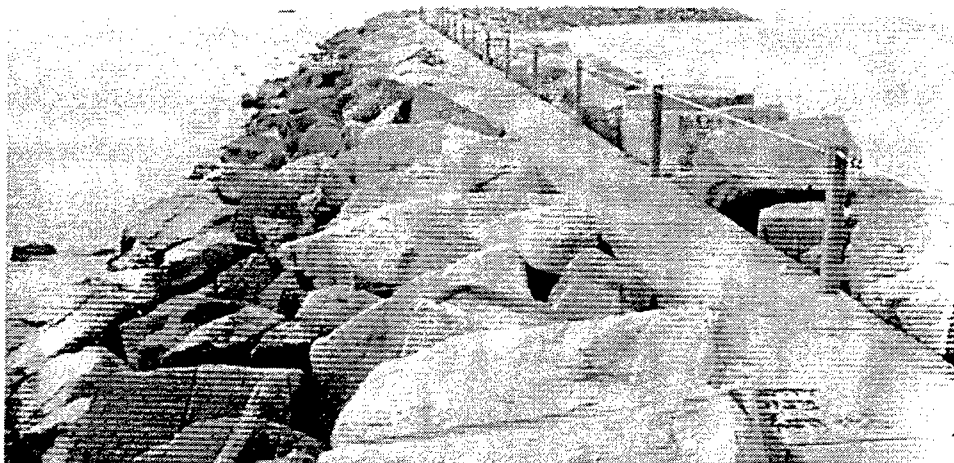
An inspection of the Cattaraugus Creek Harbor south breakwater (Figure 45) on 8 October 1997 revealed voids in the armor stone layer at two locations on the lake side of the breakwater along the curved portion (sta 15+00 and sta 16+50). The void at sta 16+50 is shown in Figure 46. An additional void was observed on the head of the structure (Figure 47), which resulted in a steep slope. During the inspection several broken stones were observed sporadically along the structures; however, overall the structure appears to be in good condition. The north breakwater was inaccessible and not inspected. It is protected by the curved south structure.

Figure 45. Cattaraugus Creek south breakwater looking lakeward

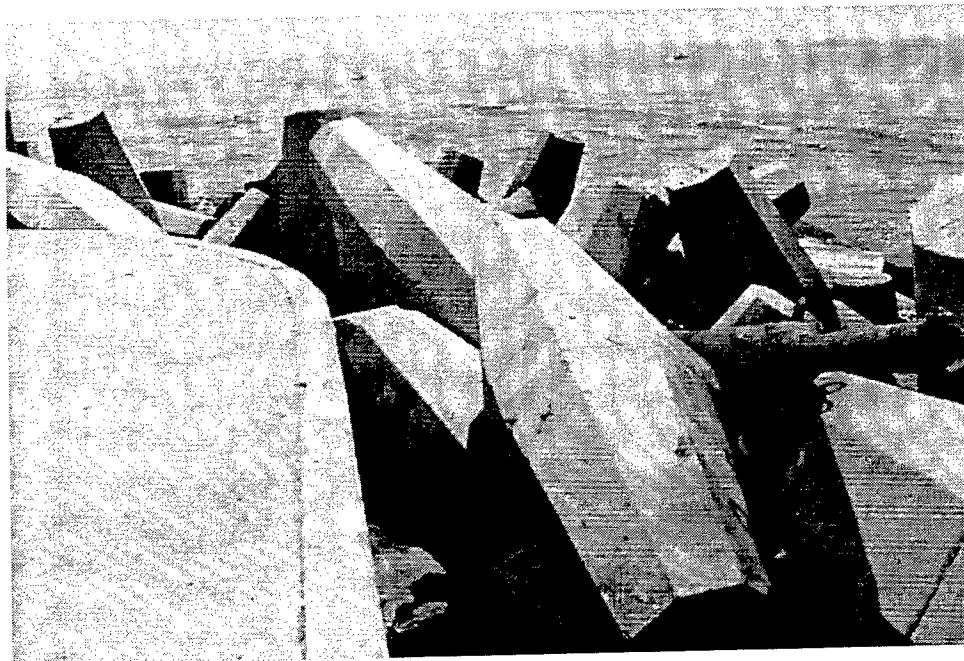
The Manasquan Inlet jetties were inspected on 10 June 1997. The 14,515-kg (16-ton) dolos armor units are shown in Figure 49. Visual comparisons of armor unit positions on the north jetty to 1994 photomaps revealed that several units had moved slightly. Horizontal movement appeared to range from 0.15 to 0.6 m (0.5 to 2 ft). In addition, it appeared that the downslope portions of most of these units had slightly lost

Figure 49. 14,515-kg (16-ton) dolos armor units on Manasquan Inlet jetties

elevation. Seven of these units were adjacent to the void area (Figure 50) on the south side of the jetty head, which had been identified in the 1994 survey. The void area also appeared slightly larger than in 1994. Two armor units on the north side of the structure and four on the seaward tip of

the jetty also had moved downslope slightly. Most of these movements probably may be attributed to a major storm that occurred in 1995. Inspection of the south jetty revealed that two armor units on the north side of the head had moved slightly shoreward. The area at the head of the south jetty, where the emergency repair work had been completed, appeared to be intact and performed well during the 1995 storm (Figure 51). The storm had washed the lighthouse structure onto the dolosse armor (Figure 52). No additional armor breakage was observed on either jetty during the inspection.

Subsequent to the 1997 inspection (in October 1997), void areas of both jetties were rehabilitated with 17,235-kg (19-ton) CORE-LOC armor units. Twenty-nine CORE-LOCs were placed on the north jetty and 16 on the south jetty interlocking with the existing dolosse. In addition, nine dolosse were repositioned to improve interlocking and seven broken units were removed. Other dolosse were repositioned slightly to provide space for the integration of the new CORE-LOCs into the overall protection plan.

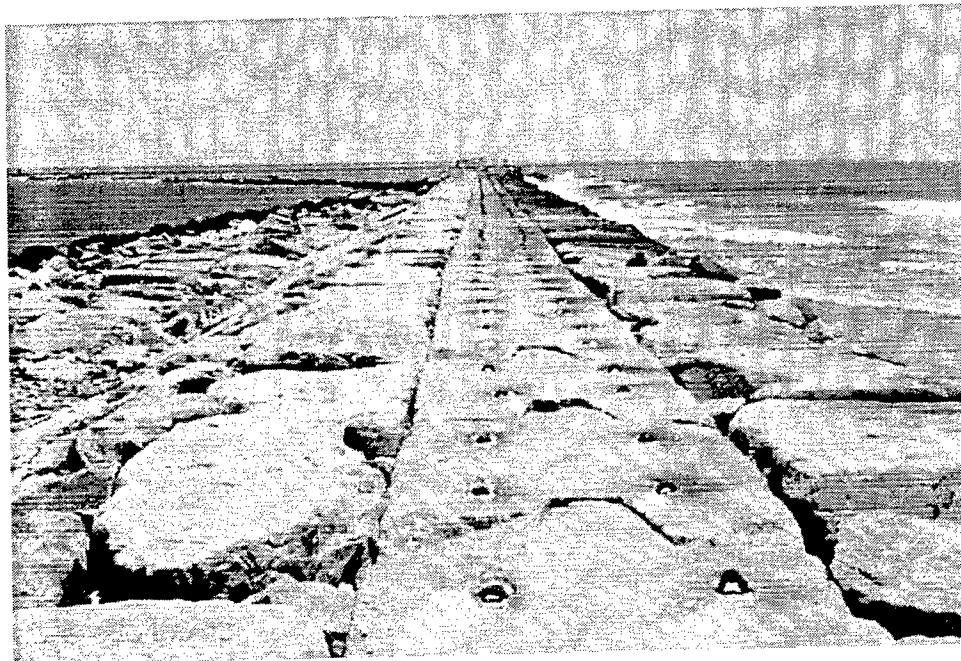
The rehabilitated south jetty and headland breakwaters at Ocean City Inlet were inspected on 11 June 1997. The rehabilitated south structure is shown in Figures 54 and 55, and the headland structures are shown in Figure 56. The inspection revealed these structures to be in excellent condition. No voids were noted, no armor stones were broken, and the cross sections of the structures appeared to be as built. It was noted that the seaward section of the old south jetty (that extending beyond sta 13+00) was in disarray. Armor stones were scattered, the crest height was inconsistent, and no definite cross section was apparent (Figure 57).

Figure 54. Rehabilitated south jetty trunk at Ocean City Inlet

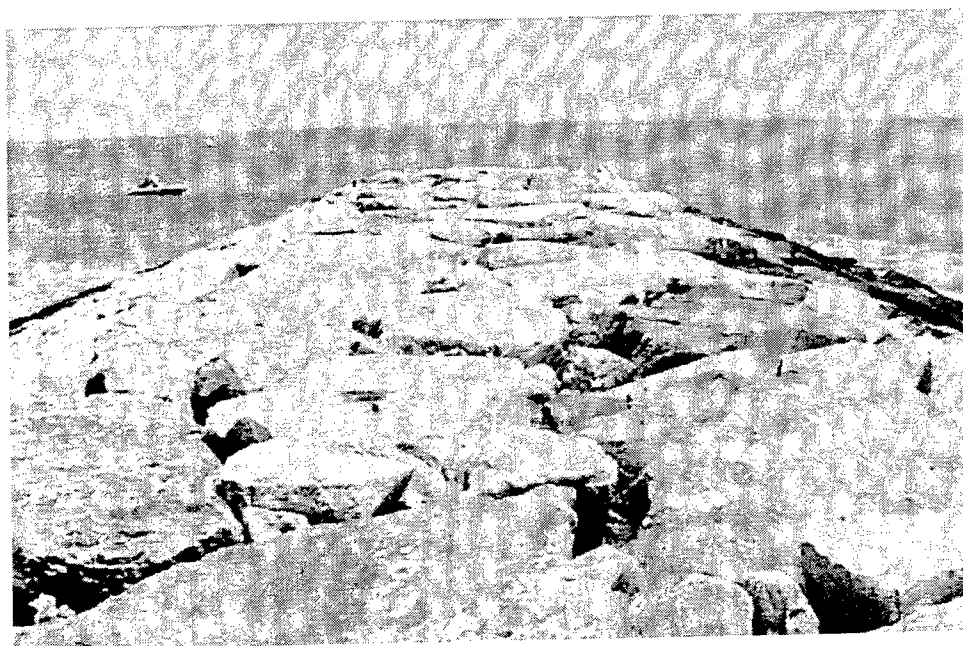
Figure 55. Head portion of south jetty rehabilitation at Ocean City Inlet

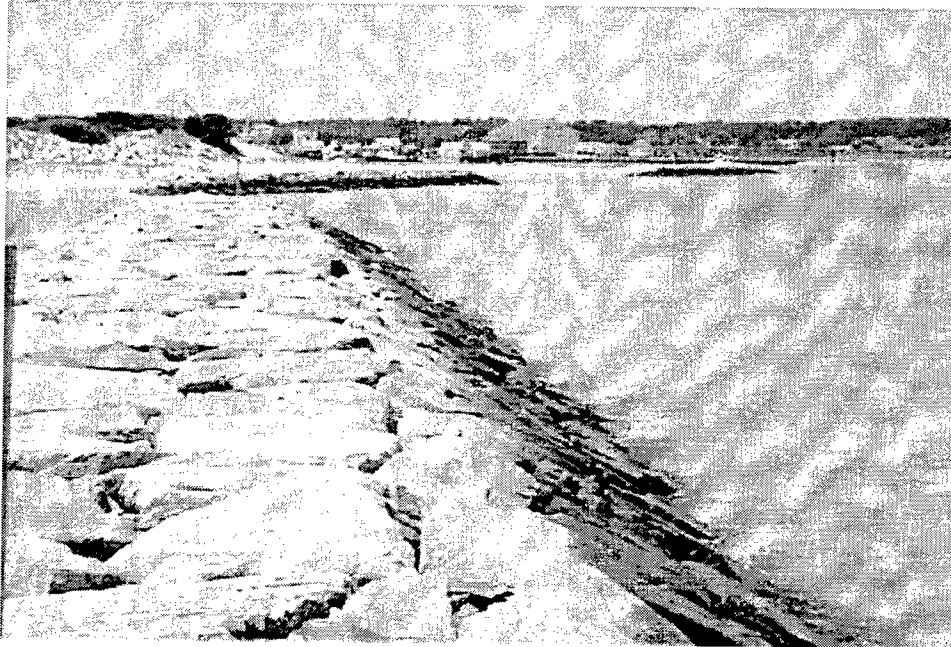
Figure 56. Headland breakwaters at Ocean City Inlet constructed to stabilize shoreline
